**DEPARTMENT OF TRANSPORTATION**

Contract #: 04-0120F4Cty: SF/ALA Rte: 80 PM: 13.2/13.9File #: 69.28**WELDING INSPECTION REPORT****Resident Engineer:**Pursell, Gary**Address:** 333 Burma Road**City:** Oakland, CA 94607**Report No:** WIR-011966**Date Inspected:** 03-Feb-2010**Project Name:** SAS Superstructure**OSM Arrival Time:** 700**Prime Contractor:** American Bridge/Fluor Enterprises, a JV**OSM Departure Time:** 1900**Contractor:** Zhenhua Port Machinery Company, Ltd (ZPMC), Changxing Island **Location:** Shanghai, China**CWI Name:** Du Zhiquan.**CWI Present:** Yes No**Inspected CWI report:** Yes No N/A**Rod Oven in Use:** Yes No N/A**Electrode to specification:** Yes No N/A**Weld Procedures Followed:** Yes No N/A**Qualified Welders:** Yes No N/A**Verified Joint Fit-up:** Yes No N/A**Approved Drawings:** Yes No N/A**Approved WPS:** Yes No N/A**Delayed / Cancelled:** Yes No N/A**Bridge No:** 34-0006**Component:** Tower**Summary of Items Observed:**

## WELDING INSPECTION REPORT

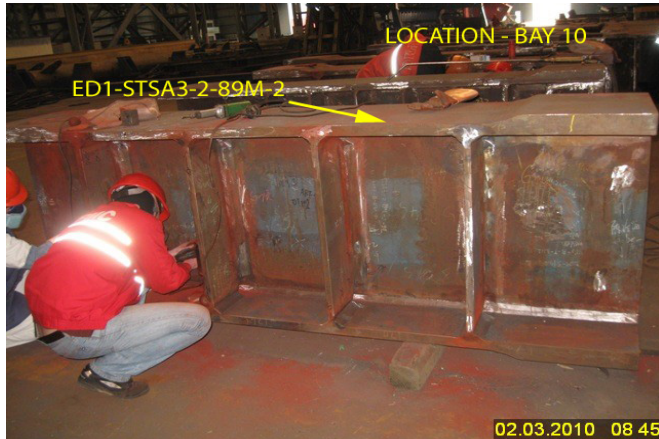
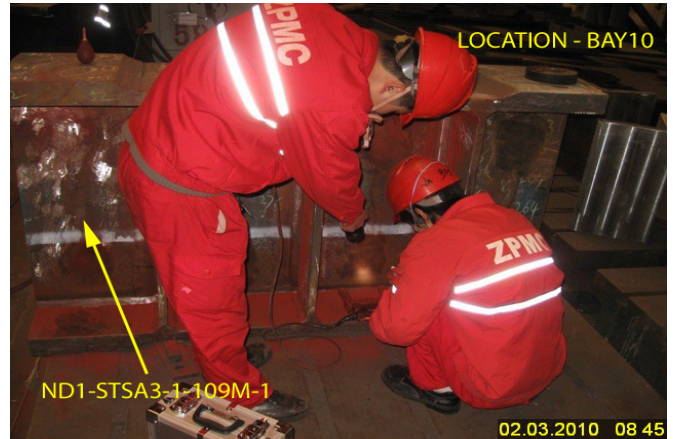
This QA Inspector observed during random Visual inspection, ZPMC Magnetic Particle Testing (MT) Inspector performed MT on Tower Strut Plate, The Item identified as ED1-STSA3-2-89M-2 and ND1-STSA3-1-109M-1 For more information see attached photos.
